Service Letter No: SL-200-082712

SUBJECT: Hydraulic cylinder (hub cap) screws

MODELS AFFECTED: **200RV, RV10 and 200A CONSTANT SPEED PROPELLERS
MANUFACTURED BETWEEN 05/03/2012 and 08/27/2012**

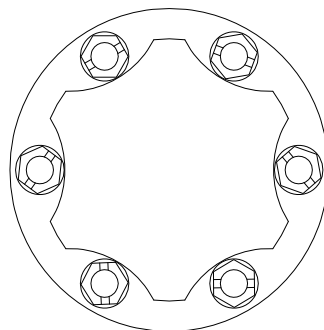
OLD STYLE
ROUND MOUNTING FLANGE

**DESCRIPTION OF
REQUIRED
CORRECTIVE
ACTION:** If the propeller has the "old" style round mounting flange **NO FURTHER
ACTION IS REQUIRED.**

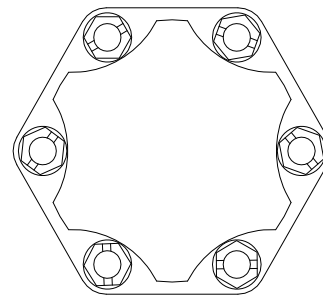
NEW STYLE
HEXAGONAL MOUNTING FLANGE

REASON: Propeller assemblies that use the 2012 "new" style 215 hub: The (14) hydraulic cylinder (hub cap) fastener holes are not tapped deep enough to allow the fasteners to be properly tightened. As such there is a possibility that the screws will crack or break over time.

If the propeller has the "new" style hexagonal mounting flange contact Whirl Wind Aviation for a no cost correction kit that contains (14) flat washers and a tube of #242 Loctite.

Working on one screw a time, each of the (14) hydraulic cylinder (hub cap) #10-24 socket head cap screws must be removed, the kit flat washer installed under the screw head, Loctite applied and then reinstalled in the propeller hub. Tightened to 25 in. lbs.
